# Manhole Inspection Summary

Manhole # S61CC\_014MH

Insp Date: **3/16/10 3:13 PM**

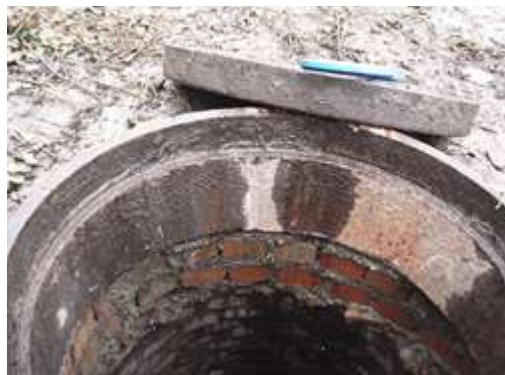
Defect 2

☒ **Leaks**

frame leaks

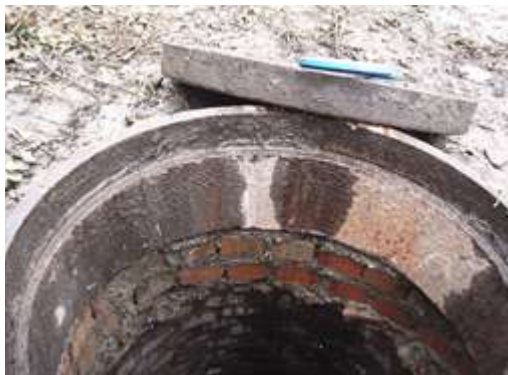
### Defect 1

frame leaks

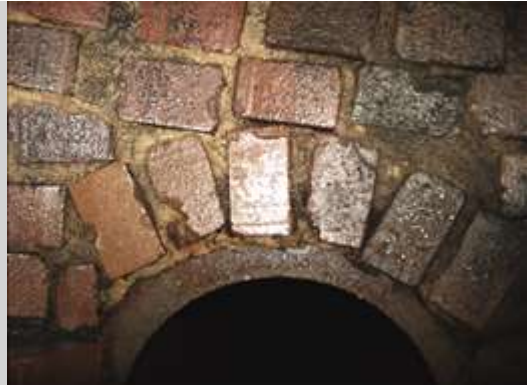
12 O'Clock Outflow

12 in. Circular Gravity Sewer  
Pipe Out @ 12 O'Clock

Pipe Height: **15.6** (in.) Rod and Bar (Angled)  
Pipe Material: **Clay** ☐ Pipe Lined  
Invert Depth: **12.92** (ft.) Flow Characteristics: **None**  
Deposits: ☒ None ☐ Mud ☐ Sludge ☐ Debris ☐ Grease  
Silt Depth: (in.) Deposits Extent:  
Infiltration: **None** Pipe Seal Cond: **Sound**

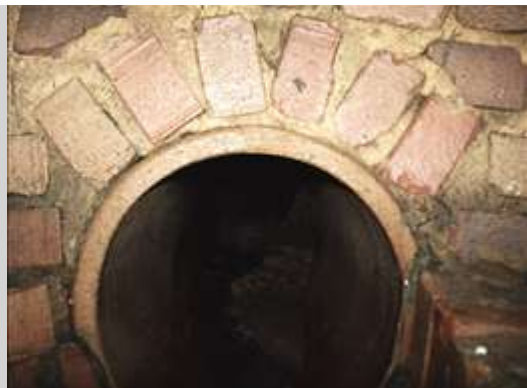
3 O'Clock Inflow

12 in. Circular Gravity Sewer  
Pipe In @ 3 O'Clock

Pipe Height: **15.6** (in.) Rod and Bar (Angled)  
Pipe Material: **Clay** ☐ Pipe Lined  
Invert Depth: **12.67** (ft.) Flow Characteristics: **None**  
Deposits: ☒ None ☐ Mud ☐ Sludge ☐ Debris ☐ Grease  
Silt Depth: (in.) Deposits Extent:  
Infiltration: **None** Pipe Seal Cond: **Sound**

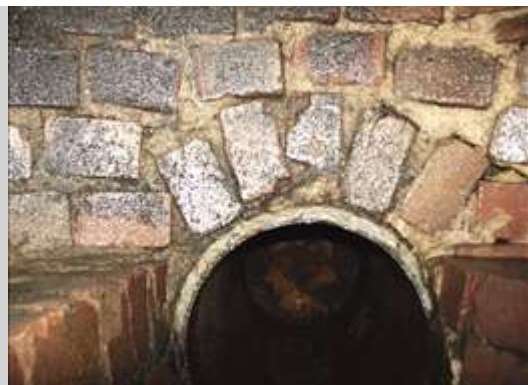
9 O'Clock Inflow

10 in. Circular Gravity Sewer  
Pipe In @ 9 O'Clock

Infiltration: **None**

Pipe Seal Cond: **Sound**
